Manhole Inspection Summary

Manhole # S35YY_027MH

Insp Date: **12/22/06 11:24 AM**

Location Address: **107 32ND ST**

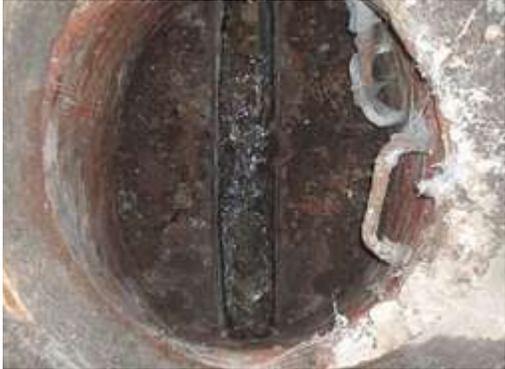
Top View

Corroded steps. Evidence of surcharge - Bench debris. Channel debris.

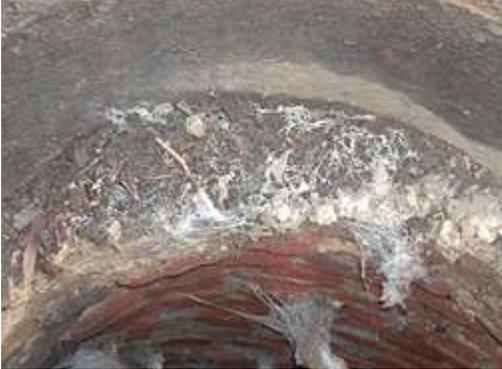
Defect

Frame leaks. Frame offset. Adjustment deterioration and infiltration.

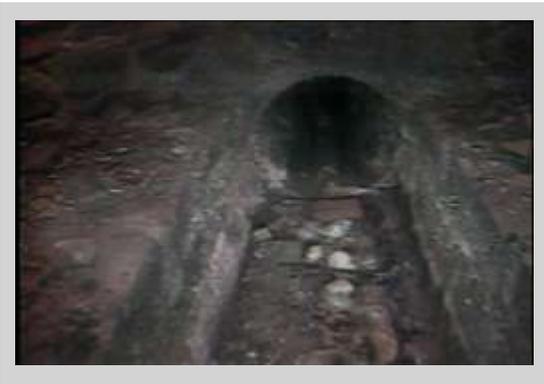
8 in. Circular Gravity Sewer Pipe Out @ 12 O'Clock

Deposits: None **Mud** Sludge **Debris** **Grease**

Silt Depth: **0** (in.) Deposits Extent: **Light**

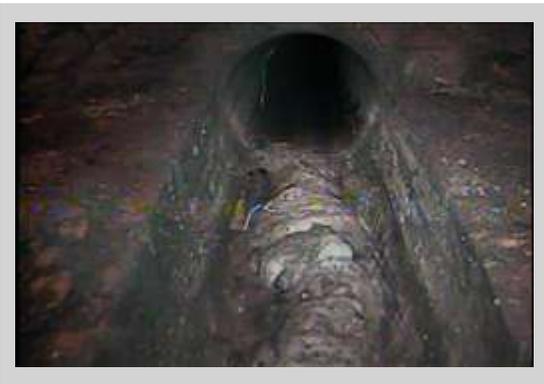
8 in. Circular Gravity Sewer Pipe In @ 6 O'Clock

Deposits: None **Mud** Sludge **Debris** Grease

Silt Depth: **0** (in.) Deposits Extent: **Light**
